**THE LO RESIDENCE
CASE STUDY**

THE USE OF HIGH VOLUME FLY ASH CONCRETE
AT THE LO RESIDENCE

Prepared by: Roland Haebler, M.A.Sc., P.Eng.
THE HAEBLER GROUP, GENERAL CONTRACTORS

March 31, 2003

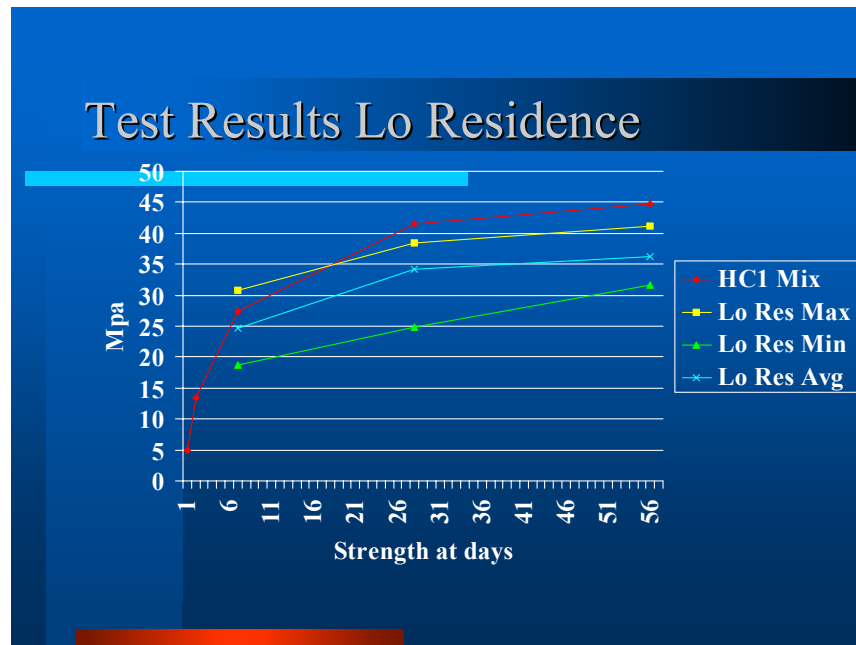
Figure 3: Test Results of Lo Residence HVFA Mix as Compared to HC1 Mix

The actual test results for all concrete tested using the HVFA mix are shown in Appendix A. Figure 3 shows a summary of the results compared to the HVFA mix used at The Waterfall building. As can be seen the average maximum values for the Lo Residence mix achieved lower strength characteristics than the initial HC1 mix. Since the strength in any concrete mix is in large part related to the strength of the aggregate, the author suspects that it was the use of the 14mm aggregate for aesthetic reasons that resulted in this lower strength. However, the actual test results do show that even the minimum test results are above the specified 30MPa at 56 days requirement.

set #	7-day	28-day	56-day
123	25.2		
122	31.8		
121	26.4	38	
120	30.8		
118	27.6	24.9	
117	26.4	38.5	
		37.3	
		37.9	
116	26.1	32.6	
	25.2		
	25.4		
115	22.7	34.7	38.7
114	25.7	34.2	39.5
			37.3
			38.4
113	22.4	33.3	35.3
			36.8
			36
112	23.9	35.5	36
			35.8
			35.9
111	22.2	26.9	31.6
			31.8
			31.7
110	24.4	37.3	39.5
			41.2
			40.3
109	23.4	34.3	36.8
	22		37.7
			37.3
106	23.2	34.3	
		35	
		34.7	
105	21.2	31.8	33.1
102	18.7	32.1	35.3
			34
			34.7
average	24.7	34.1	36.3
max	30.8	38.5	41.2
min	18.7	24.9	31.6

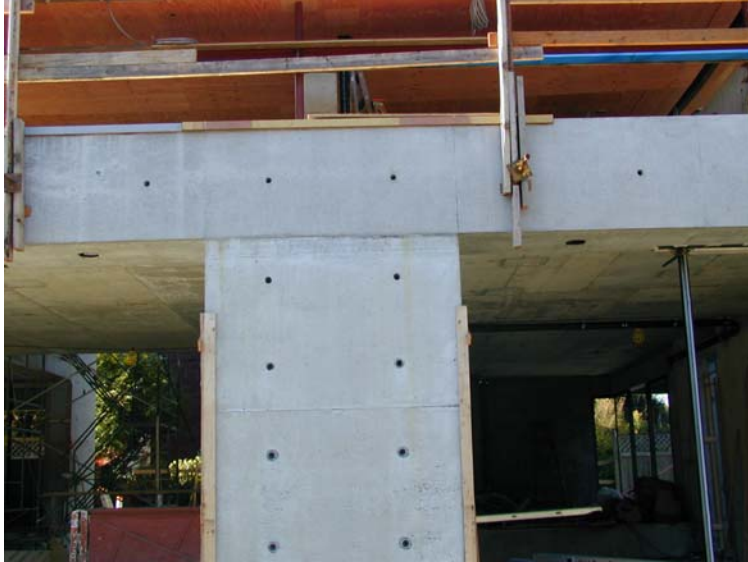
Figure B-3: Close-up of Form Fresh Finish, Wall and Slab Edge Cold Joint
